# GELCOAT BLISTERS

## A GUIDE TO OSMOSIS REPAIR

Repairing of fibreglass boats following osmosis damage with WEST SYSTEM ® Brand epoxy.

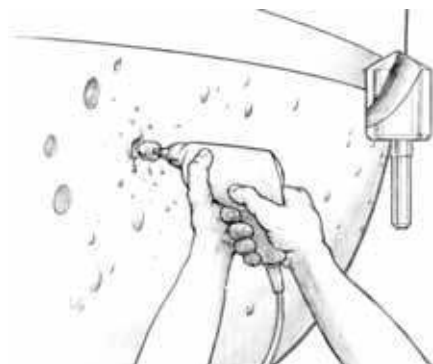
**Figure 4.1.** A variable speed drill with a countersink bit can be used to open blisters while providing good depth control

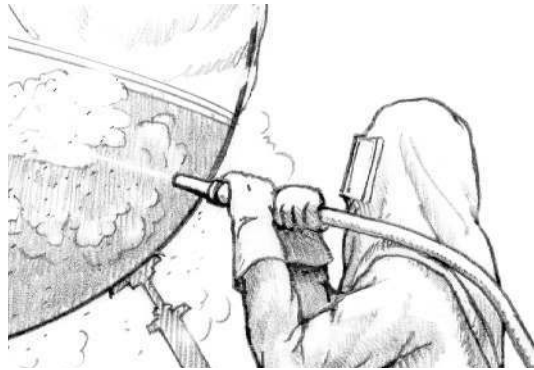
**Figure 4.3.** Sandblasting is a common method of opening blisters and abrading the hull

This method is also a potential health problem because of the airborne dust generated. Antifouling paint must be removed before sandblasting as failure to do so may result in small particles of paint becoming embedded in the laminate. This may create subsequent bonding problems.

Do not drive gelcoat particles into the softer, underlying laminate nor remove excessive quantities of the laminate. Remove between 90% and 95% of the gelcoat by sandblasting and then complete the process by sanding. After the gelcoat is removed, inspect the laminate for delamination and any further damage; sound the hull for voids.

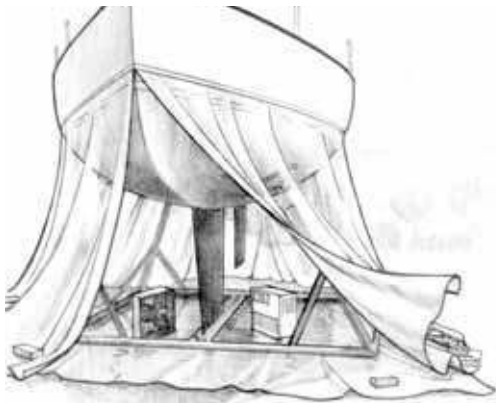
**Figure 5.1.** Drying the hull can be accelerated by tenting the hull with a plastic skirt taped just above the waterline.

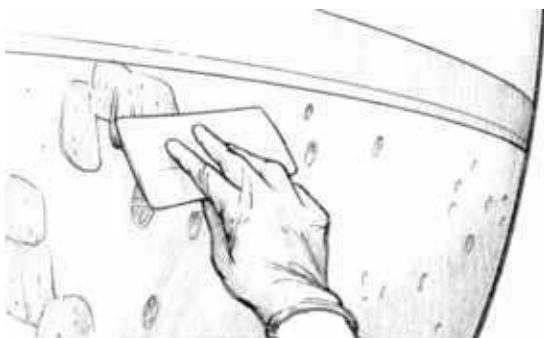
Figure 6.2 Use a squeegee to apply fairing compound, and slightly overfill the area. Shape the mix to blend with the surrounding contour.

3. Prepare a fairing mix with WEST SYSTEM epoxy and either 407 Low Density filler or 410 Microlight filler and blend in filler until it becomes a non-sagging “peanut butter” consistency. **Note:** The thicker the fairing mix, the easier it will be to sand when cured.
4. Trowel the thickened mix into the wetted surface with a plastic squeegee, working it into all voids and depressions.
